Station Notes for B013, Penny Creek, PnyCrk013bwa2007

Pacific Northwest PBO strainmeter network, May, 2008

B013 pnycrk013bwa2007

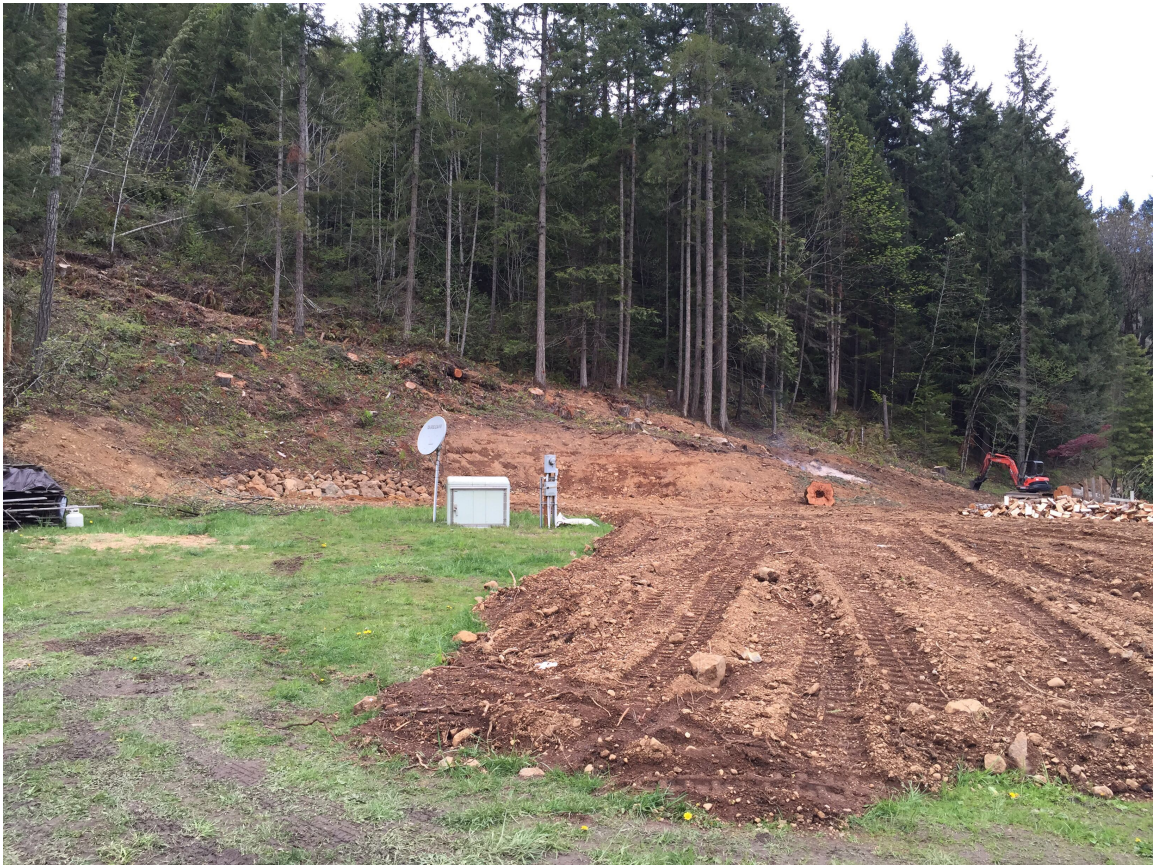
- April 15, 2015 – Swapped out GTSM Environmental Box. All old boards were left on-site. Adjusted chops and quads. CH1 was not very responsive. Unable to check chops or match quads. Worked with quadratures for some time. Swapping the RT board did nothing. Will watch GTSM DQ for the next month. If there is no improvement the old GTSM environmental box will be reinstalled. They are logging, and made a road very close to the Strainmeter.
