Station Notes for B088, SkyOks088BCS2007

Latitude: 33.37495 (WGS 84)
Longitude: -116.62052 (WGS 84)
Elevation: 1403.00 m / 4603 ft
Install Depth: 160.02 m / 525 ft
Orientations: CHO=216.2 CH1=153.2 CH2=96.2 CH3=66.2
Install Date: January 28, 2007
GTSM Technologies #: US29
Executive Process Software: Version 1.14
Logger Software: Version 2.02.2
Home Page: <http://pbo.unavco.org/station/overview/B088>
Notes Last Updated: January 13, 2020

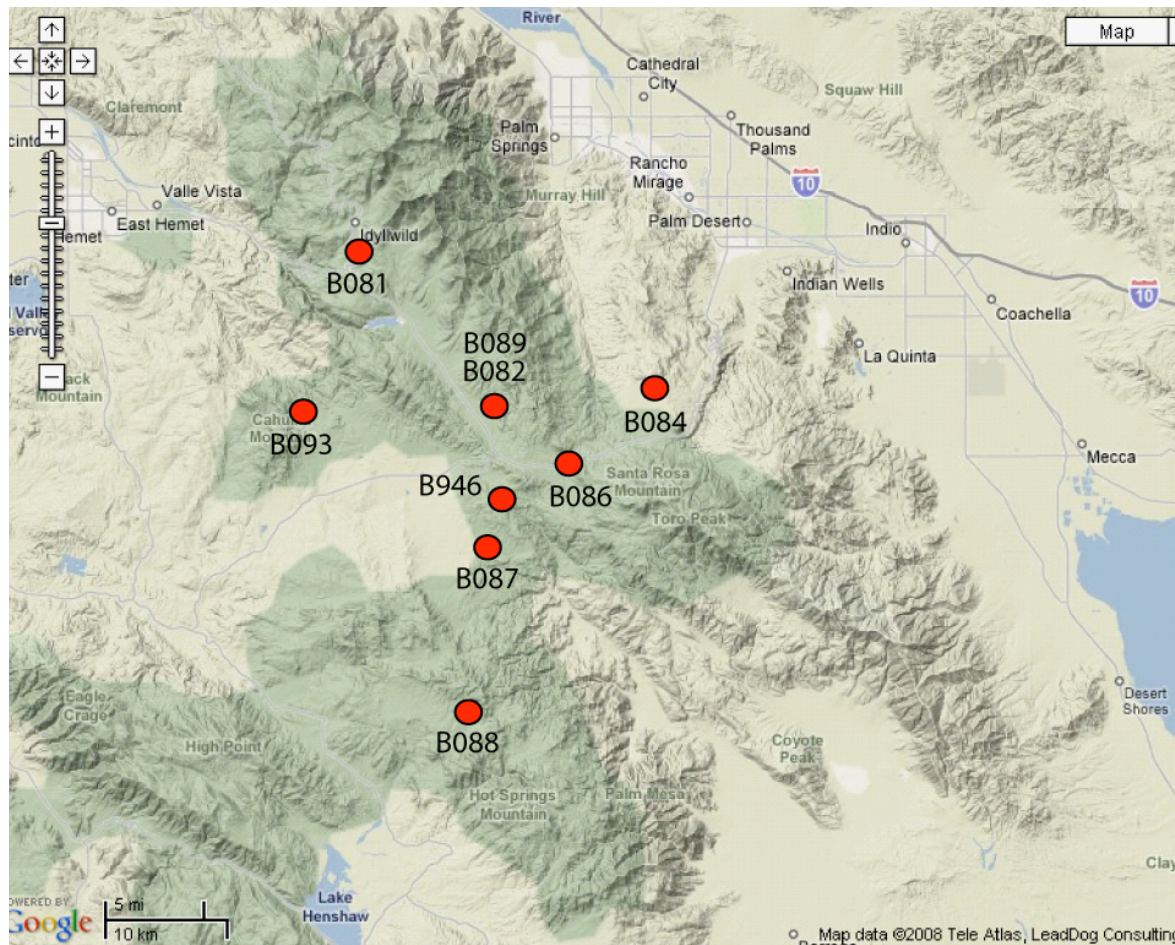
Anza PBO strainmeter network, July 2010.
