Station Notes for B202, windy202bwa2007

Latitude:	46.2447 (WGS 84)
Longitude:	-122.1367 (WGS 84)
Elevation:	1218.6 m / 3998 ft
Install Depth:	242.8 m / 796.5 ft
Orientations:	CH0=207.7, CH1=147.7, CH2=87.7, CH3=57.7
Install Date:	July 25, 2007
GTSM Technologies #:	US51
Executive Process Software:	Version 1.14
Logger Software:	Version 2.02.2
Home Page:	www.unavco.org/instrumentation/networks/status/pbo/overview/B202
Notes Last Updated:	October 14, 2020

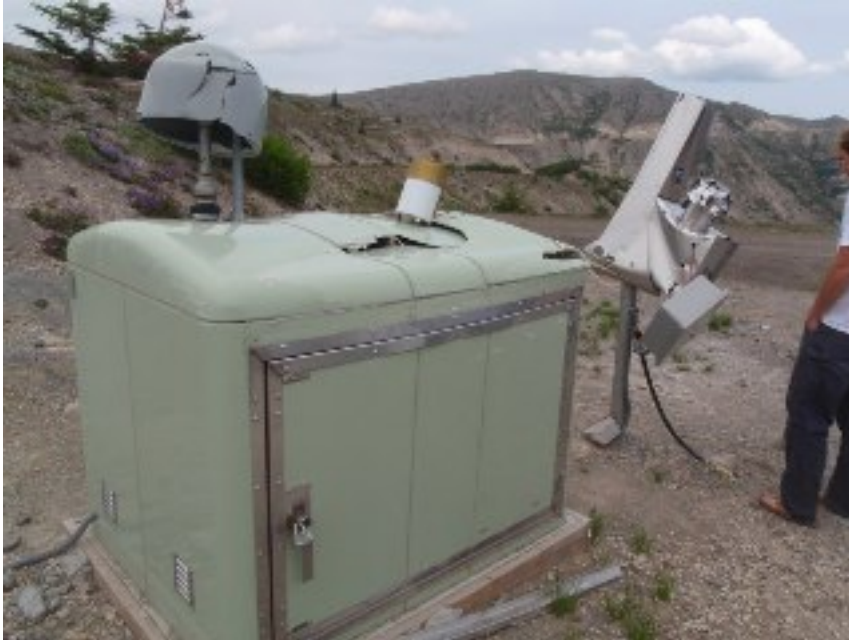
- July 25, 2008 – The site was in a dismal state when Korey and Mike visited it. The ranger told them that the snow pack had reached 20 feet in this location. A shelter like the one at the Quarry could be a good idea for this location, although Korey would recommend a slanted roof.
