Effects of the April 1st, 2014 GLONASS Outage on GNSS Receivers

AGU FALL MEETING 2014

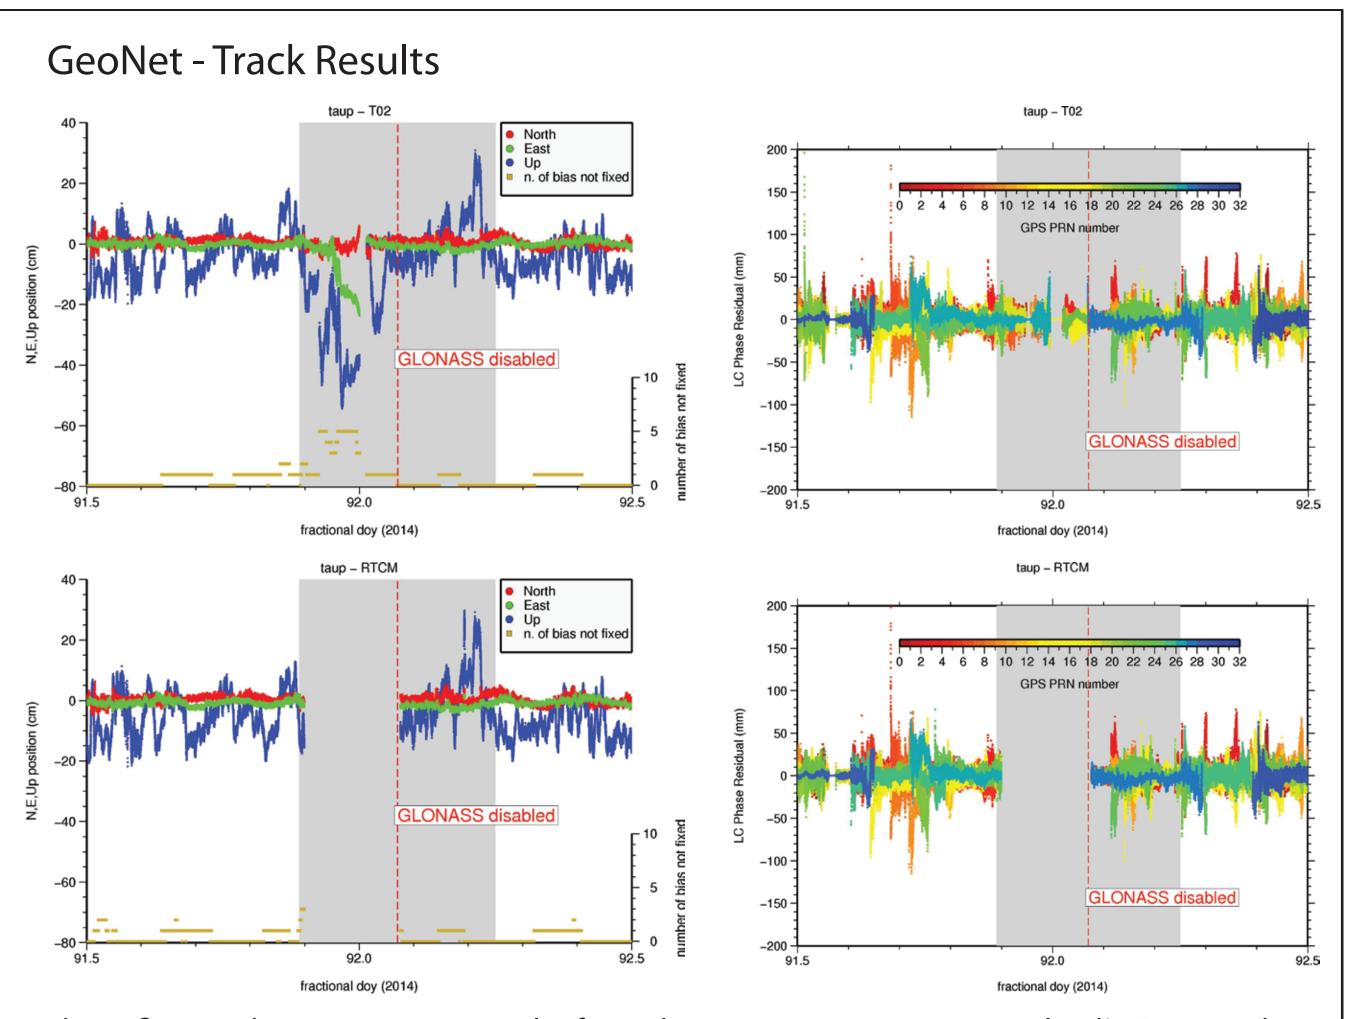
These figures show processing results from the station TAUP in New Zealand's Geonet. The upper two figures show processing results from the raw T02 files. The lower two figures show the processing results from data collected via RTCM streams. The outage affected the RTCM processing up to the time when GLONASS tracking was disabled.

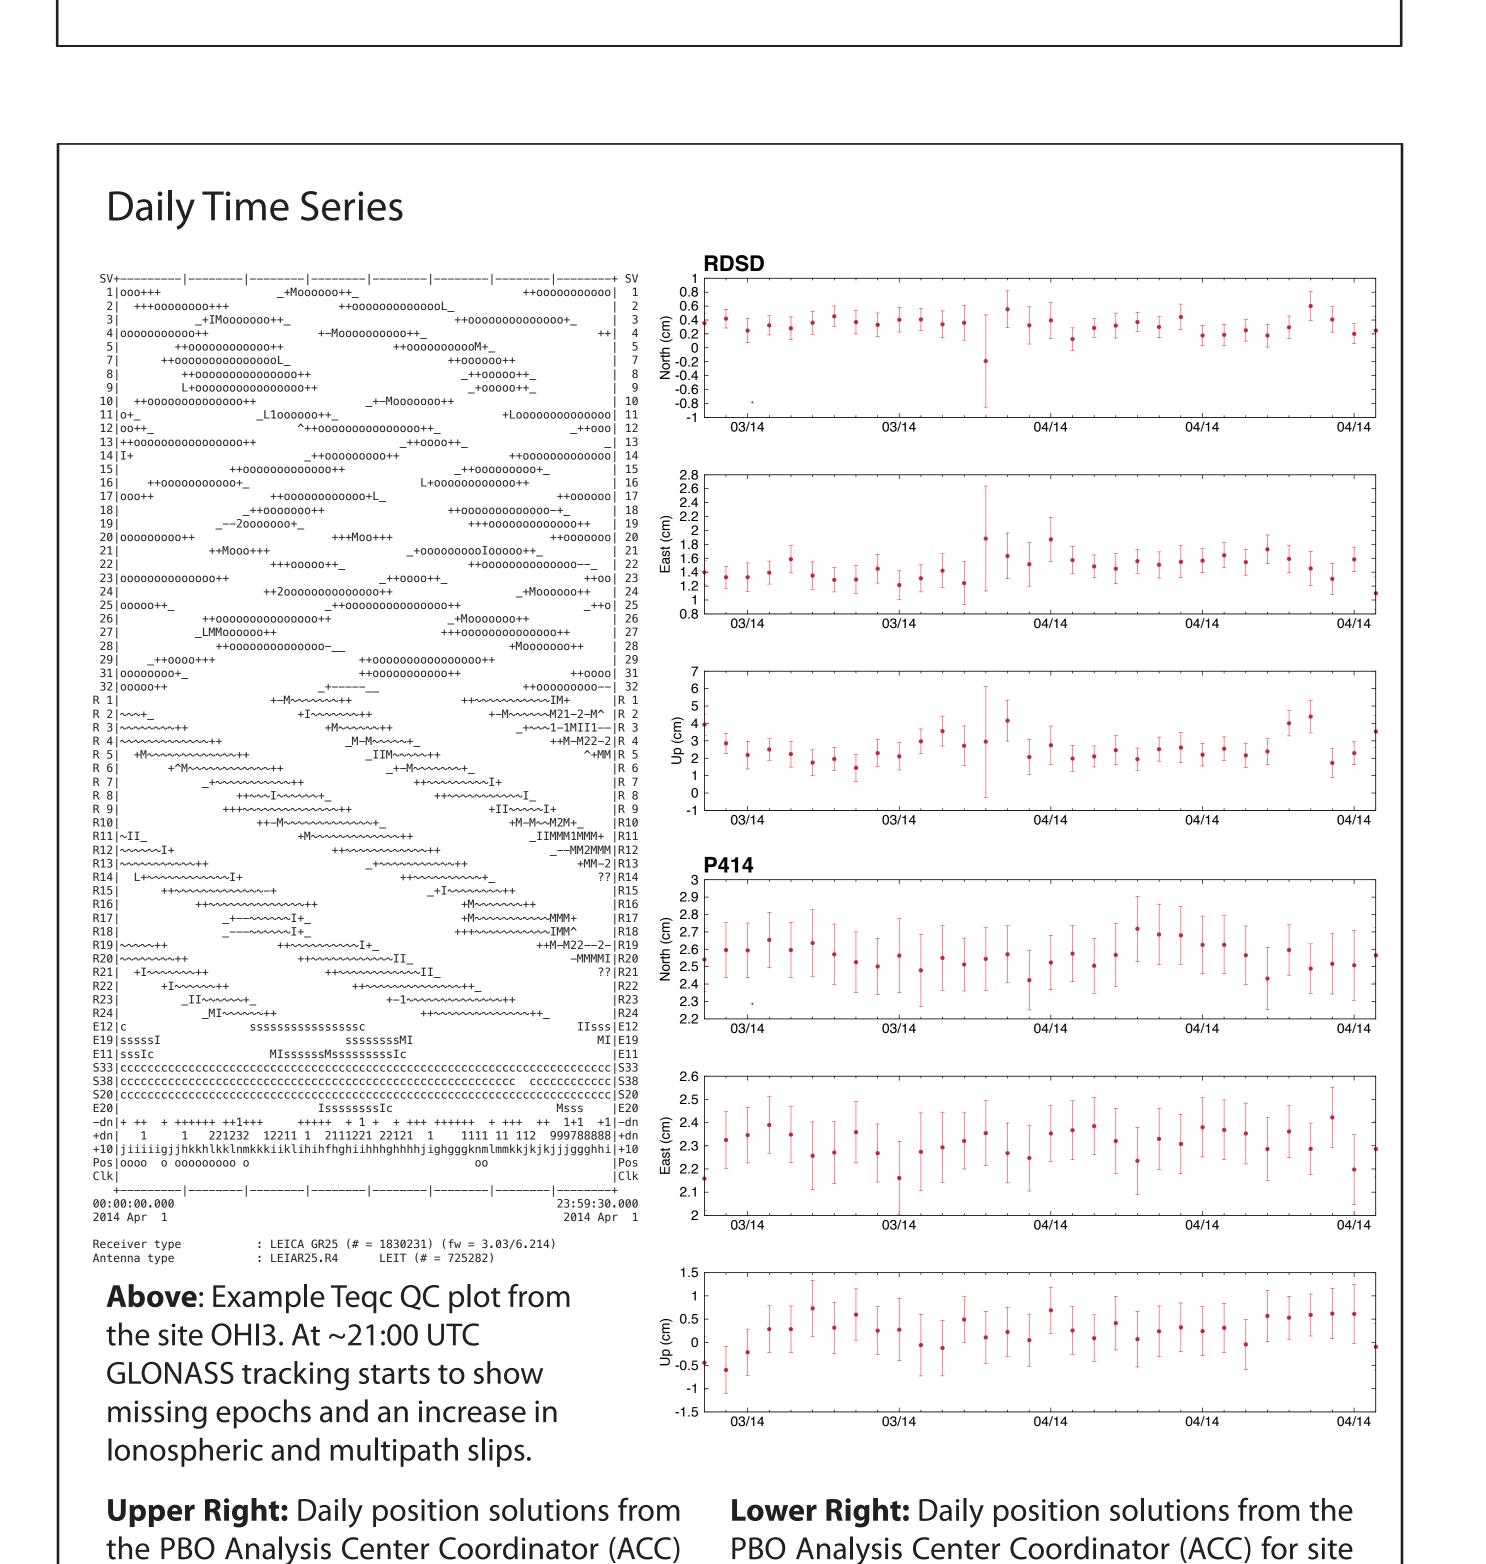
P414 (Trimble NetR9) located in southern

Washington state. At sites where only a small

portion of the days data were lost due to the

outage, the daily time series were unaffected.

for site RDSD (Trimble NetR9) located in Do-

minican Republic. The GLONASS outage

had a negative impact on the daily postion

time series at sites where a significant por-

tion of a given days GPS observations were

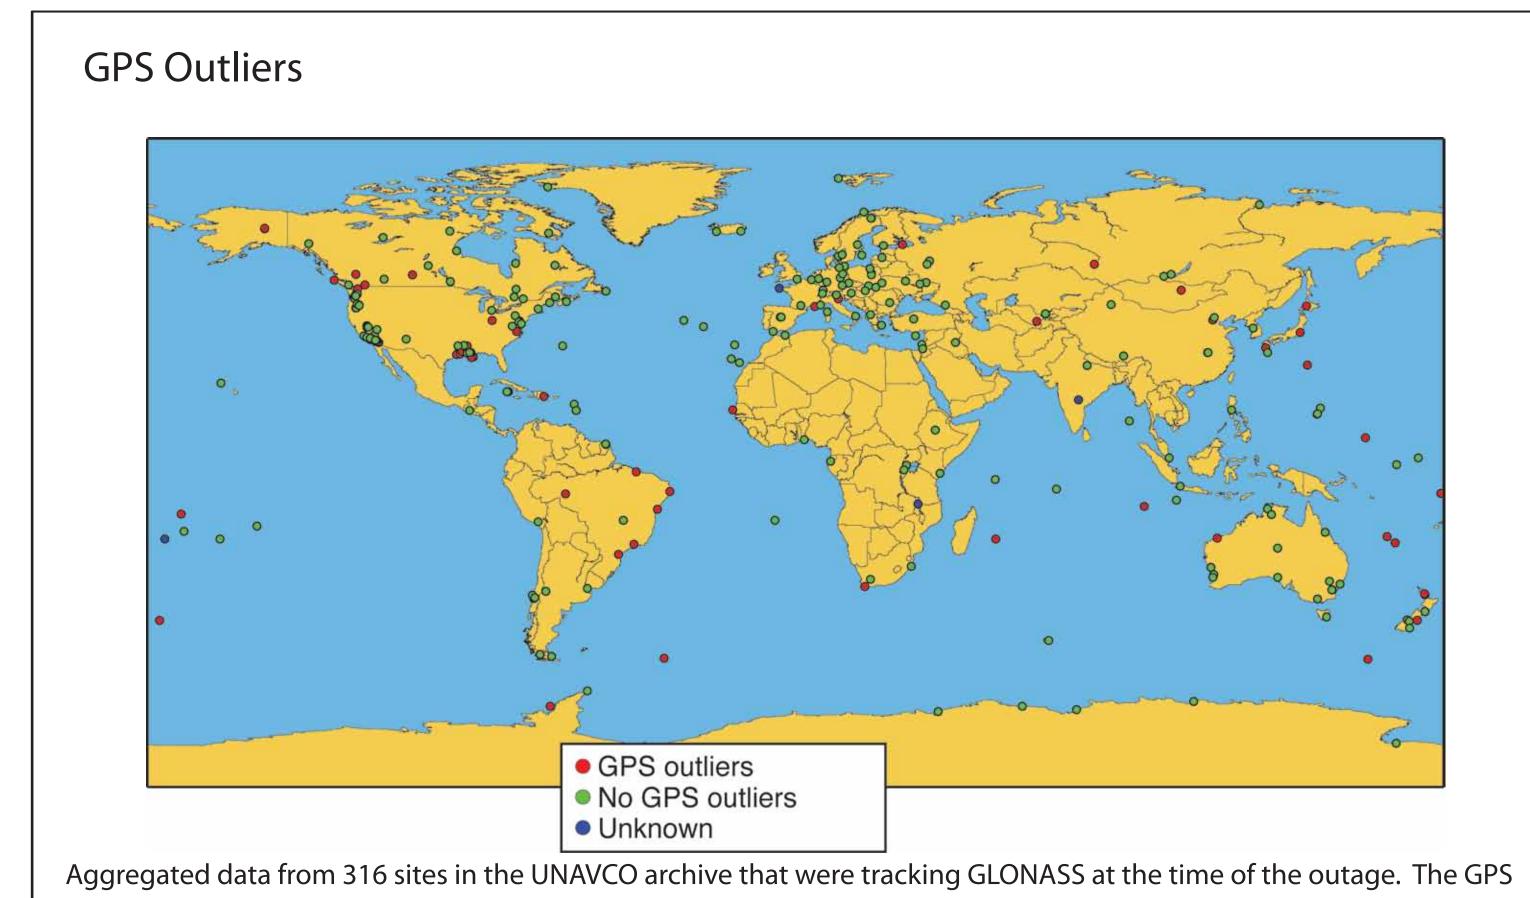
Aggregated data from 316 sites in the UNAVCO archive that were tracking GLONASS at the time of the outage. The GPS outlier flags were determined from missing epochs and by manual inspection of visible satellites figures. We found that 67 of the 316 sites (21%) had some problems tracking GPS during the outage.

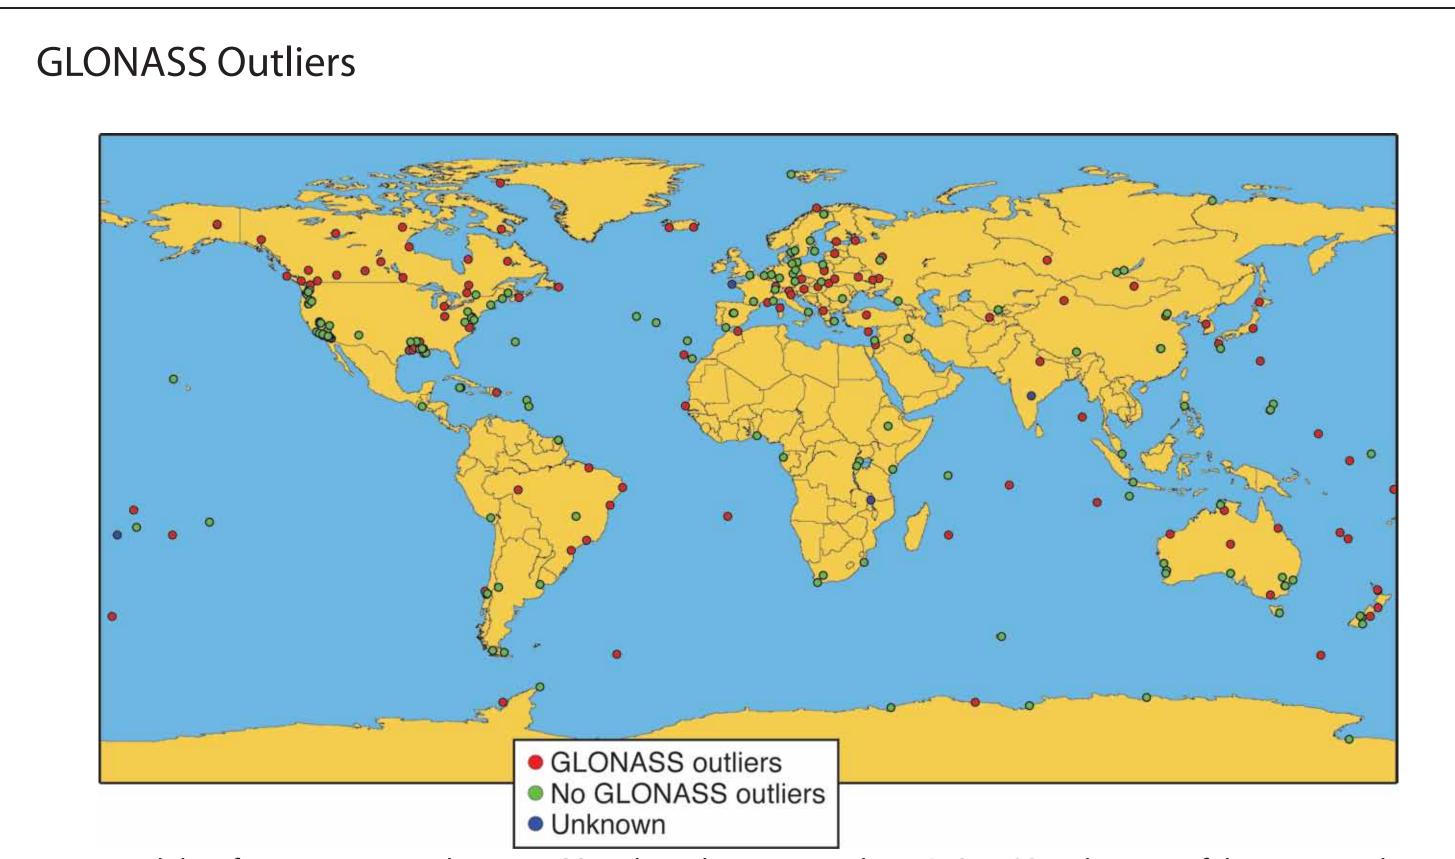
Aggregated data from 316 sites in the UNAVCO archive that were tracking GLONASS at the time of the outage. The GLONASS outlier flags were determined from missing epochs and by manual inspection of visible satellites figures. We found that 131 of the 316 sites (41%) had some issue tracking GLONASS during the outage.

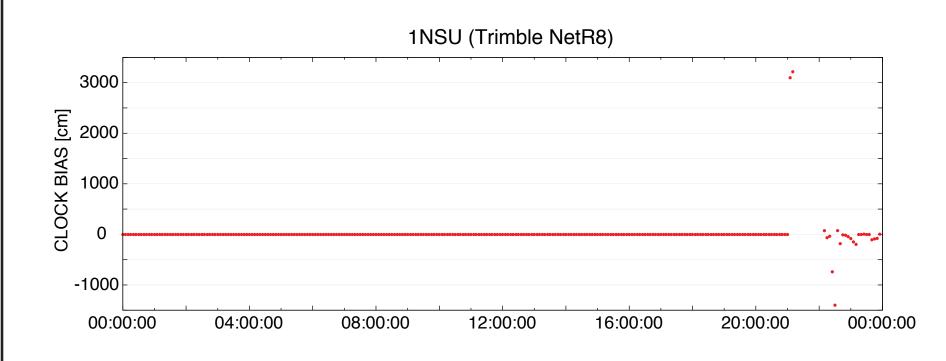
Clock bias estimates as computed by GIPSY-OASIS for the station 1NSU on day 91 of 2014. Clock steering on this Trimble NetR8 receiver exhibited large outliers following the beginning of the outage at 21:00 UTC. The increased clock noise did not stop until the end of the GLONASS outage on the following day.

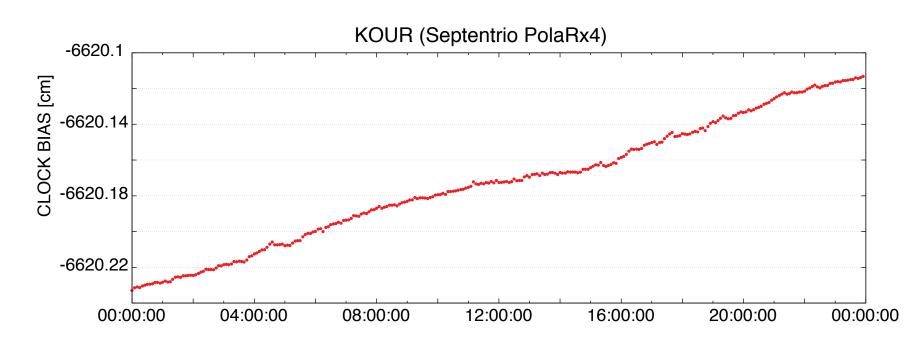
Clock bias estimates as computed by GIPSY-OASIS for the station KOUR on day 91 of 2014. The internal clock at this station is slaved to an external H-maser and the receiver does not apply any clock steering. This Septentrio PolaRx4 receiver continued to function nominally throughout the outage. We observed nominal tracking of GPS and GLONASS at the majority of sites where a superior external reference was used instead of the internal clock.

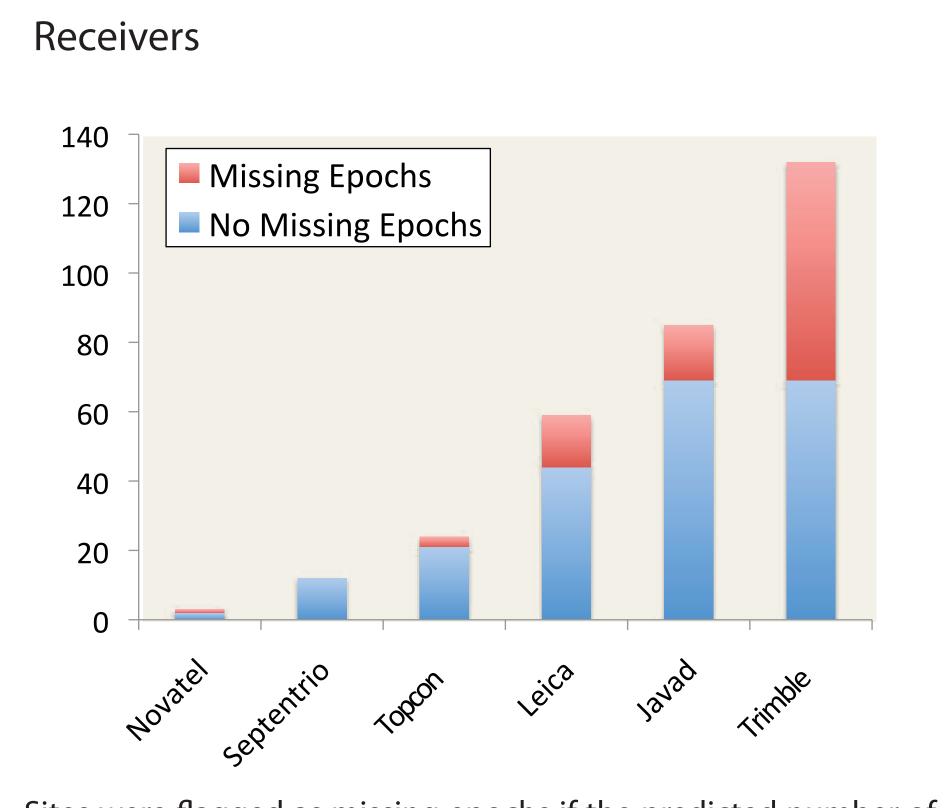
Sites were flagged as missing epochs if the predicted number of epochs did not match the number recorded in the UNAVCO archive. The results have been organized by receiver make.
