Station Notes for B009, pacgeosi1bbc2005

Latitude: 48.648667 (WGS 84)
Longitude: -123.451167 (WGS 84)
Elevation: 15 m / 49.2 ft
Install Depth: 225.25m / 739 ft
Orientations: CH0= 271.4, CH1= 211.4, CH2= 151.4, CH3= 121.4
Install Date: 2005-09-14
GTSM Technologies #: US08
Executive Process Software: Version 1.14
Logger Software: Version 2.12
Home Page: www.unavco.org/instrumentation/networks/status/pbo/overview/B009
Notes Last Updated: October 1, 2019

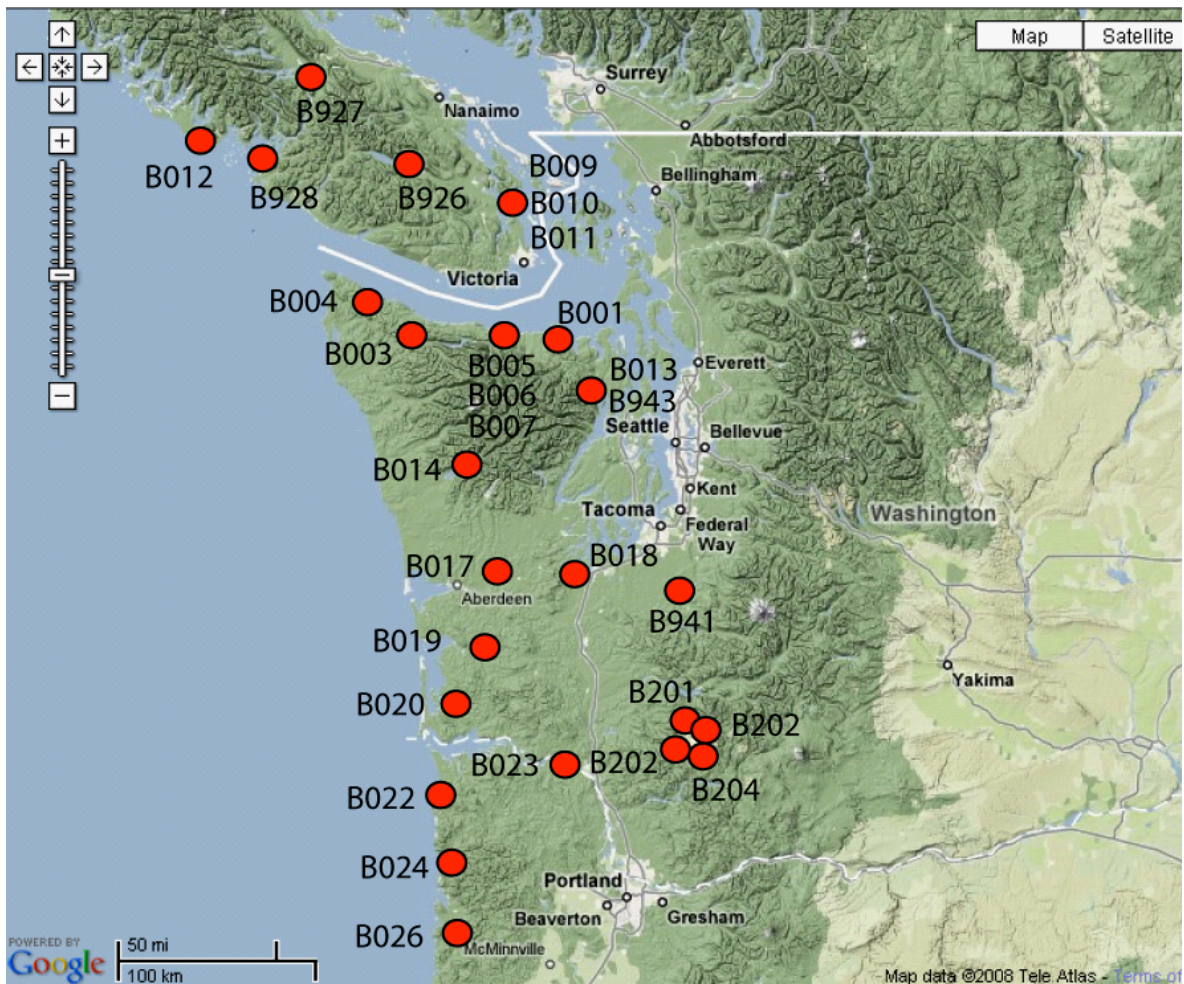
Pacific Northwest PBO strainmeters, 17 October 2007.
