Station Notes for B022, Sea Side, seaside22bor2006

Pacific Northwest PBO strainmeter network, April, 2008

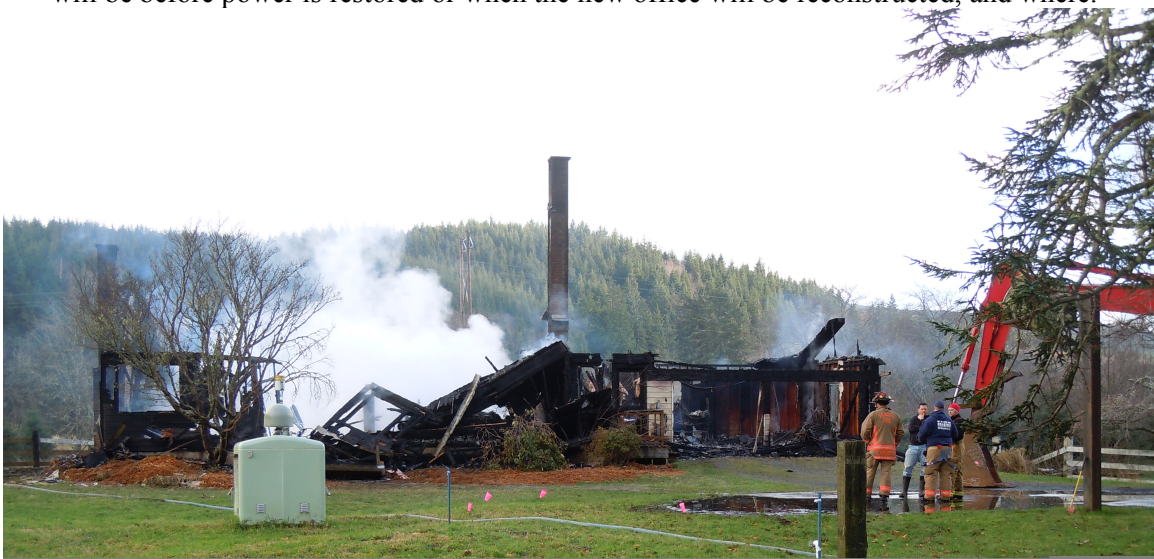
- December 5, 2012 – The office building/house for the North Coast Land Conservancy in Seaside, Oregon, burned to the ground as of this morning. The fire department advised that the box and equipment at the surface were heated quite a bit and to let you know that possibly there could have been damage to it. It is too early at this point in time to know how soon it will be before power is restored or when the new office will be reconstructed, and where.

- December 10, 2012 – Liz met with the Director of the Conservancy to discuss the power issue prior to visiting the site. He was willing to let us take power from the nearby barn or have our own drop. They do plan on rebuilding the house/office, but that will be in half a year, if not longer. There was no heat damage to the site. Batteries were at 11.5V and the LVD had powered down all equipment except the GTSM. There were people working at the Conservancy and they allowed Liz to plug the site into a nearby barn. A hole was drilled into the enclosure to run the extension cord through (this will be used for a MetPack in the future). She moved the Sprint Proxicast power into the main power block. The BSM side was offline because it was wired into the comms power block. Liz was alerted that the property has a theft problem, and the Seaside Detective stops by and talks to her. Lize plans to hire an electrician to provide a drop from the nearby barn to the site. John Wickershame, representing the Conservancy, will approve the work. More batteries should be added to the main bank.
