### Station Notes for B082, pathfi082bcs2006

# B082 pathfin82bcs2006

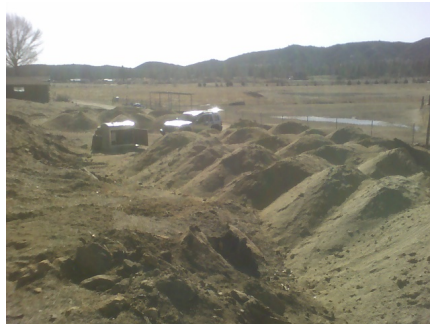
- This strainmeter is part of a 2-strainmeter cluster. Strainmeter B082 is sited a few 100 meters from B089
- On August 29, 2006 the logger clock jumped ahead by 1024 weeks during an onsite procedure when the short power outage occurred without a prior logger standby request. This problem was fixed by Mick Gladwin on 7 December 2006.
- A change in strain rate on both Pathfinder strainmeters beginning January 2, 2007 was caused by 100 to 150 tons of dirt being placed next to the strainmeter sites.

B089, Pathfinder Ranch January 8, 2007. View is to the southwest.

- April 24, 2007 – Most of the dirt has been removed from the site. There are still two piles of dirt near the top of the Pathfinder-2 site but all other dirt has been moved.
- Pumping began on April 25, 2007, producing a saw tooth like strain signal.
- Sensitivities of all EH channels corrected in the dataless on March 4, 2010.
- The pore pressure sensor is installed at 74 feet with the packer inflated directly above the sensor. However, the packer has probably failed.
