### Station Notes for B023, cataln023bor2008

Latitude:	46.1112 (WGS 84)
Longitude:	-123.0787 (WGS 84)
Elevation:	177.4 m / 582 ft
Install Depth:	240.2 m / 788 ft
Orientations:	CH0=206.5, CH1=146.5, CH2=86.5, CH3=56.5
Install Date:	May 16, 2008
GTSM Technologies #:	US70
Executive Process Software:	Version 1.14
Logger Software:	Version 2.02.2
Home Page:	<a href="http://pbo.unavco.org/station/overview/B023">http://pbo.unavco.org/station/overview/B023</a>
Notes Last Updated:	August 8, 2020

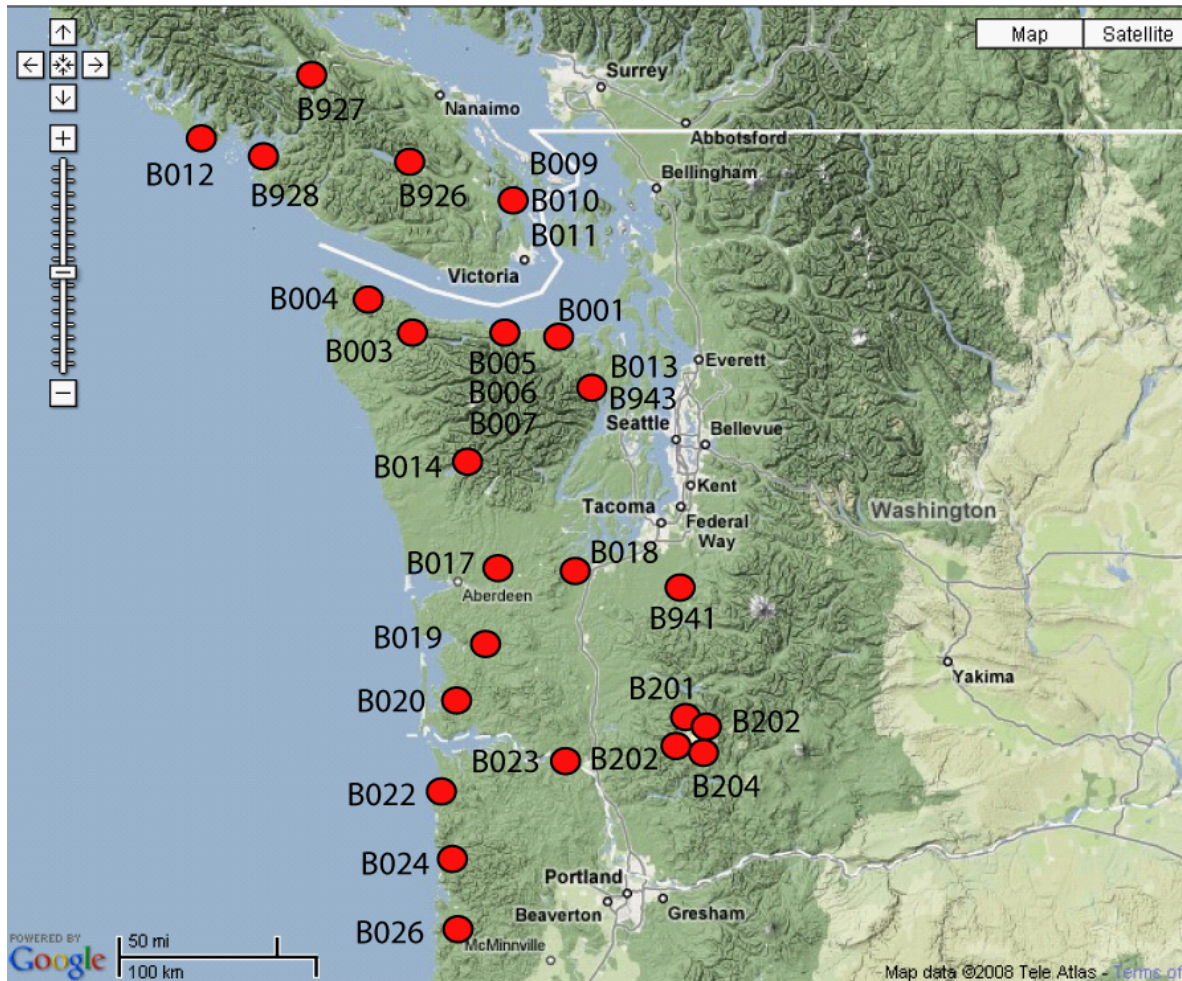
B023 cataln023bor2008  
46.1112 -123.0787 177.4 m

Pacific Northwest PBO strainmeter network, April 2008
